LA-6210-MS

Hazard Classification Test of GAU-8 Ammunition by Bonfire Cookoff with Limited Air Sampling

Los Alamos Scientific Laboratory
of the University of California
LOS ALAMOS, NEW MEXICO 87545

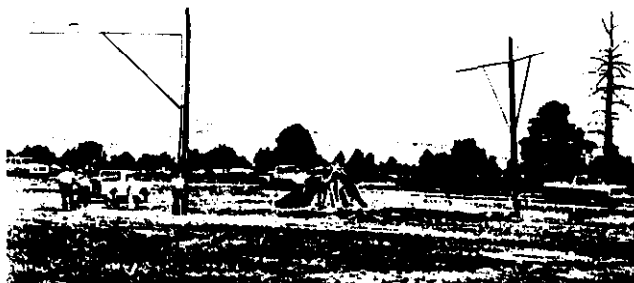
Fig. 3.
Overall arrangement of stack and samplers.

connected as inverted L's on utility poles to act as probes. These probes projected over the fire to collect air samples without being disabled by heat or shrapnel. Large glass fiber filters (20 x 25 cm), which can operate at high temperature, collected the aerosol with very high efficiency. The three pole-mounted samplers were operated at a flow rate of 0.0165 m³/s, with the probe intake about 7.6 m above ground. Two other high-volume samplers (capacity 0.033 m³/s) were located 1.0 m above the ground about 21 m downwind of the bonfire. Figure 3 shows overall arrangement of the stack and sampler probes.

Table II lists the samplers and locations of the probe intakes during the test. The hinged feature of the pole-mounted probes permitted adjustment of the sampler intake to account for the wind direction at the start of the test. Azimuth is referenced clockwise from true north.
